BUREAU OF RECLAMATION
HYDRAULIC LABORATORY

EXPERIENCES OF THE BUREAU OF RECLAMATION
WITH FLOW-INDUCED VIBRATIONS

Laboratory Report No. Hyd-538

September 30, 1964

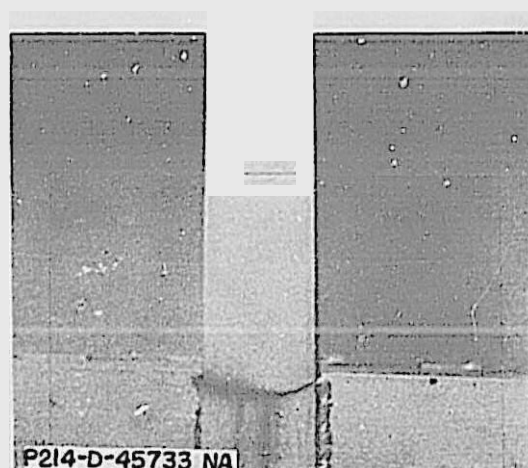
B. Typical cracking through three of the 4- by 3/8-inch vertical tie bars.

In ensuing years, reports of vibration in a number of other radial gates were received. In some instances, conditions had been so severe that fracturing had occurred in secondary and even in primary structural members. One example is provided by Little Dry Creek check in the Friant-Kern Canal in California. During annual maintenance of the structure in 1960, the left gate of this three-gate check was found to be damaged (Figure 1A). Three of the 4- by 3/8-inch vertical tie bars were fractured, and the 12-inch WF beam second from the bottom was cracked through the entire web and through the downstream flange (Figures 1B and 1C).

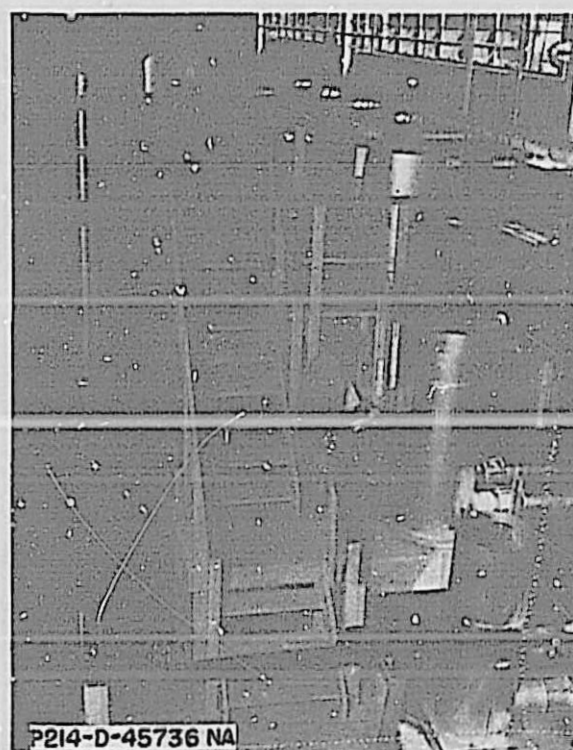
A. Laboratory model of distribution system.

Although these amplification possibilities exist, a pipeline would still run without surging if no source of initiating oscillations were present. An attempt to find the most persistent of these sources by field observation proved fruitless because of the impossibility of seeing into the pipes when water was running in them. A laboratory model was therefore built and fitted with windows and transparent pipe sections which would permit such observations to be made (Figure 8A). The pipe stands were constructed of 20-inch-diameter steel pipe fitted with sheet metal baffles with adjustable crests. These pipe stands were connected by 125-foot lengths of 8-inch-diameter pipe which had 180° bends at midlength so that the pipe stands could be grouped together. Plexiglass windows in the pipe stands permitted observers to see into the interior below water level. At the upper end of the system a half stand was attached to a head box so the wall of the head box took the place of the baffle. Water was pumped into this head box and entered the model by flowing into the half stand. A plunger, operated by a variable speed motor, provided a means of surge initiation. A length of transparent pipe was inserted in the 8-inch-diameter line at the half stand as shown in Figure 8B.

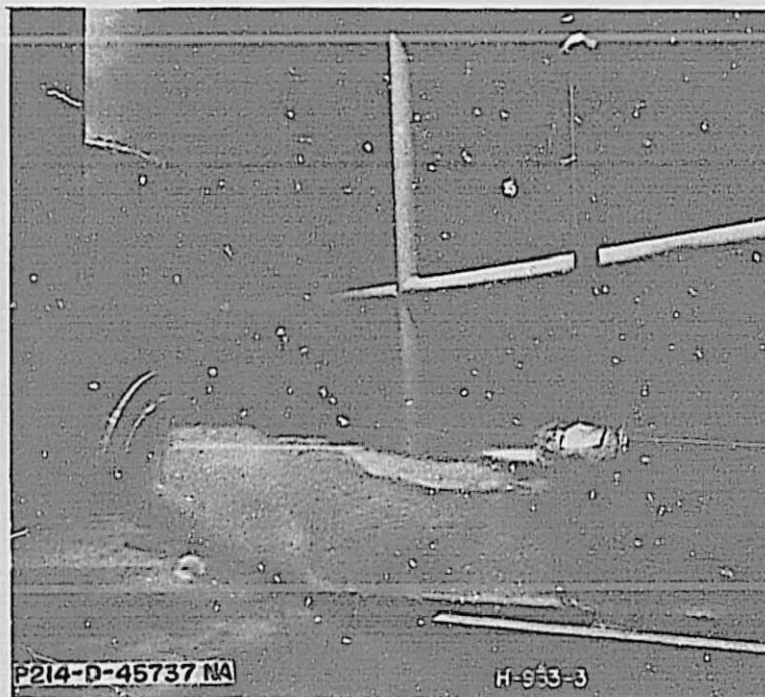
B. Air bubble entrapped in transparent pipe section just downstream from a pipe stand.

After watching the flow conditions in the transparent pipe, the mechanism of the auto-oscillation which initiated the most persistent of the field surges became apparent. The nappe falling over the baffle carried air with it as it plunged into the pool on the downstream side of the pipe stand. This air appeared as bubbles. Some of these floated back to the surface, but part were carried into the pipe. These soon rose to the top of the pipe and collected into a long bubble. The end of this long bubble is seen in Figure 8B. Because the pipe slopes, this long bubble tends to float back up into the pipe stand but is opposed by the impact of the water coming into the pipe from the pipe stand. However, as the bubble grows, the bouyant force grows with it and finally part of the bubble blows back into the pipe stand. The volume vacated by the air is immediately filled with water whose kinetic energy delivers an impulse to the system and initiates an oscillation of small amplitude. This oscillation has the natural period characteristic of the reach. The velocity changes associated with the oscillations influence the time when the next blowback will occur. Observation shows that this occurs at a time in the cycle which will permit energy to be fed into the oscillation. The accumulation and release of air thereafter lock into step with the oscillation and feed enough energy into it to maintain it at a small amplitude.
